## STABILISING RIVER BANKS FROM EROSION WITH AQUAROCKBAG

### **PROJECT DESCRIPTION**

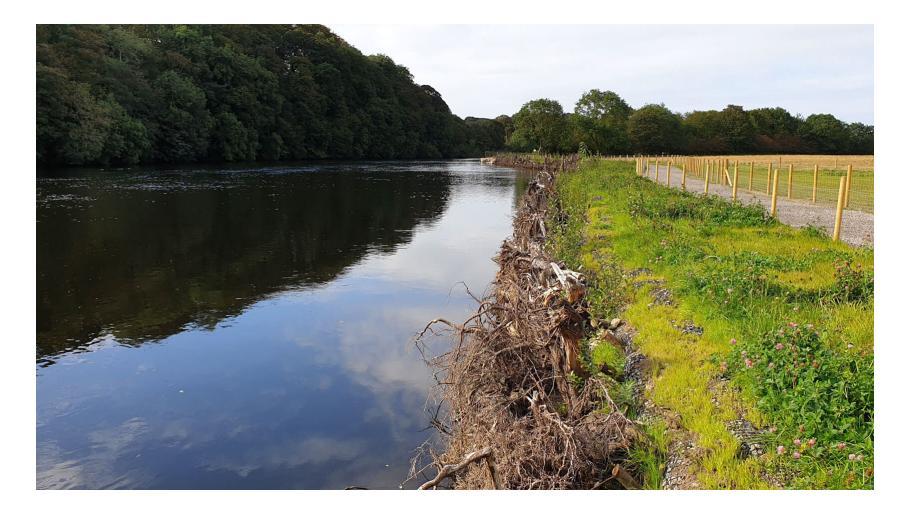
# Bioengineered design

## **Controls** erosion in **2-3**m scour pool

Due to the site's ecological sensitivity, bioengineered designs were preferred over traditional hard-engineered bank protection. Challenges arose with the scour pools, where bioengineering techniques alone were insufficient to control erosion in water 2-3 metres deep. To address this, AquaRockBag was installed alongside these techniques.
