GEOFABRICS CASE STUDY

ROCKFALL PROTECTION AT ALPINE RESORT WITH STEELGRID HR & GRASSROOTS

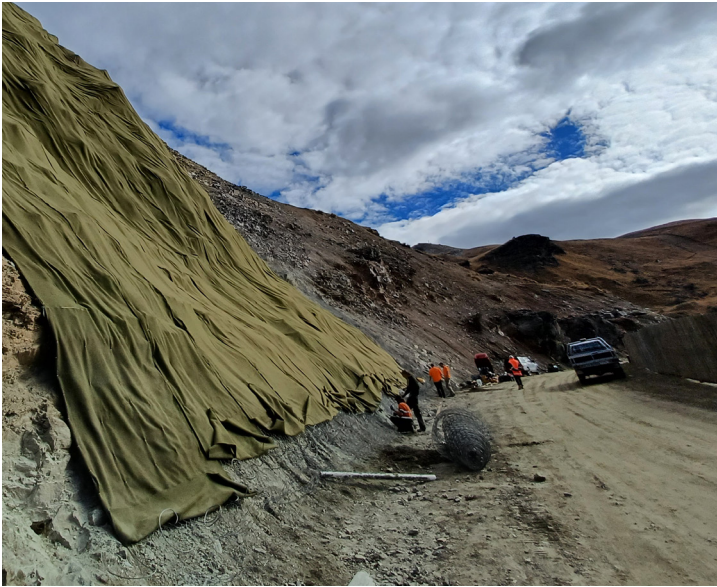
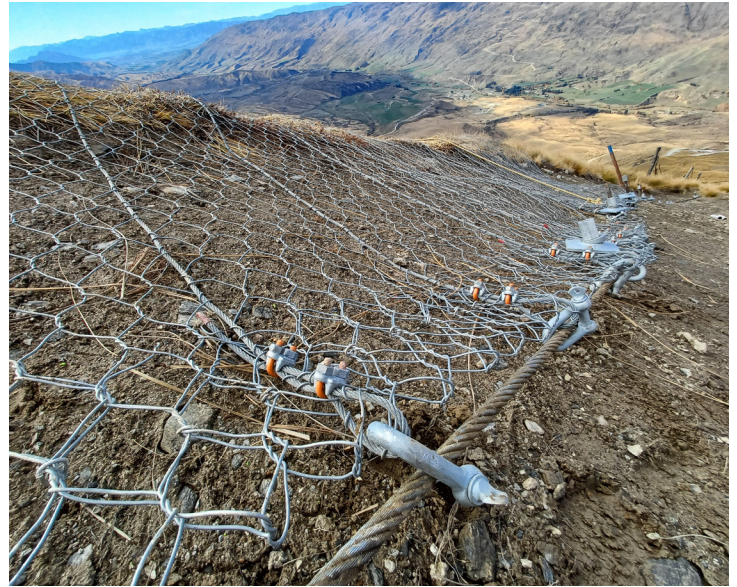
Total coverage of
3,200m²

Effective
rockfall mitigation

To prepare the site for the rockfall protection works, vegetation at the crest of the slope was cleared to create a level surface. This was followed by the installation of crest anchors at the designated spacing. The crest rope was then connected to the anchors, and the Steelgrid HR50 mesh was installed.

Alongside the Steelgrid HR50 mesh, the client requested a mat product solution that was UV-resistant and durable enough to withstand windblown dust. Grassroots synthetic erosion control mats were suggested for its durability, having undergone real-time UV exposure testing over a 10-year period. These Grassroots mats were later laced on top of the Steelgrid HR50 mesh.

In total, approximately 3,200 m² of Steelgrid HR50 mesh and Grassroots mat were installed to mitigate the rock fall hazards and control dust. This enabled the re-opening of the trail for mountain bikers during the summer months.
